**Flood Control Project Maintenance
Levee Inspections**
LMA District Cover Sheet
Spring 2020 Levee Inspection Results

Reclamation District No. 0341 Sherman Island

Waterway			Bank	Unit Miles
Unit No. 01 Threemile Slough			Right	3.36
	Spring (March - May)	Summer (June - August)	(September - November) Fall	Winter (December - February)
Unit Maintenance Rating (Fall Only)				
Date of Inspection	3/25/2020 - 3/25/2020			
DWR Inspector	David Julian			
Accompanied By	Joel McElroy Reclamation District 341

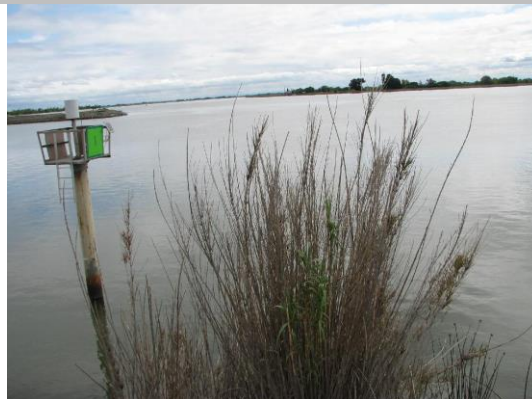
Photo 1 of 3 : UCIP_SP_2020_52252_37640.jpg

DS_ID:24215
FS_ID:52252
EP_NO: N/A
Repair Type: Non-Urgent
Crossing Status: Found
UCIP Comments: 05/05/2009 Dense vegetation limits the inspector's visibility to identify signs of pipe failure (leaks) along the slopes. Recommend removing vegetation along pipe alignment to conduct proper inspection of structure and appurtenances. (DWR UCIP - O. Magana)
FIELD_STRUCT_DESC: 30-inch steel drainage pipe through the levee, 11.1 feet below the crown. Corrugated metal cutoff wall around pipe at the center of the levee. Siphon breaker is located on both waterside (WS) and landside (LS). Pump is located on the LS approximately 300 feet from LS toe. Pipe is exposed on both levee slopes. Rock revetment present along WS slope. Marine Station number 1 located on WS with an attached small solar panel on top. [Additional Reference(s): DWR Levee Log, 1992. USACE Sacramento O&M Manual Unit No. 101, February 1962, (HLM 0.0). LMA encroachment station (STA) reference based on Map of Evacuation Route, Reclamation District 341 Sherman Island by Wagner Bonsignore Consulting Civil Engineers, A Corporation dated July 2012, STA 175+00].

Marine station posts in river identified as Station 1 near crossing.

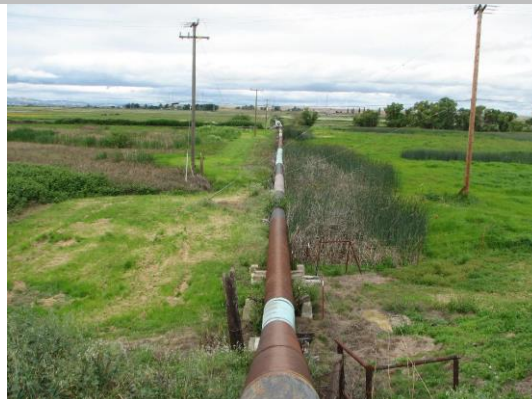
Photo 3 of 3 : UCIP_SP_2020_52252_37642.jpg

Overview of LS slope above ground once it exits levee. Pump is located approximately 300 feet from levee toe.

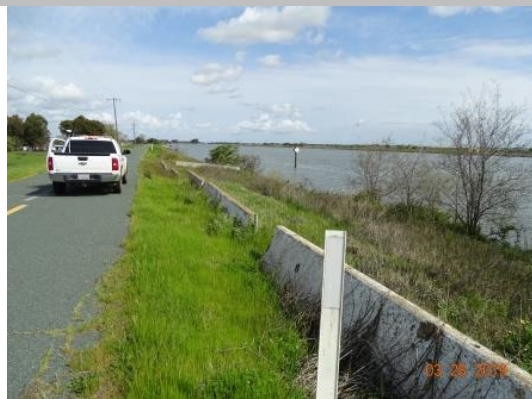
Photo 1 of 1 : SP_2020_RD0341_167_30_20200304_00005.jpg

LM Start	0.33	Rating **	A/W	Issue No.	30
LM End	0.33	Issue Type +	En	Location *	WS
Category	Earthen Levee			GPS Latitude/Longitude	
				Start	End
Item	Encroachments			38.090285 °	38.090285 °
				-121.686934 °	-121.686934 °
DWR ID	DWR_RD0341_01_s_2019_30				
Comment Code					
MA : Material					
Inspector Comment					
K-rail put in by LMA to stop vehicle traffic on the waterside slope around survey location.

View looking upstream at K-rail on the waterside shoulder. K-rail keeping vehicle traffic off of survey location. (Spring 2019)

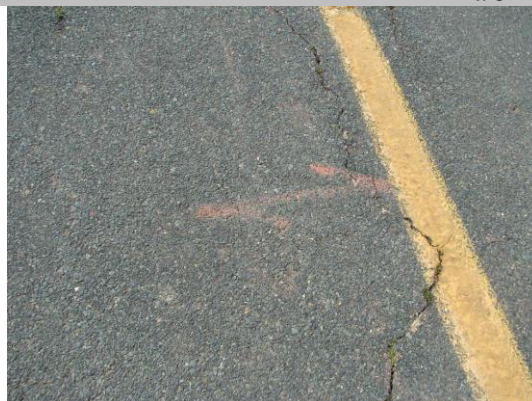
Photo 1 of 3 : UCIP_SP_2020_52253_37647.jpg

DS_ID:24110
FS_ID:52253
EP_NO: 6297
Repair Type: Non-Urgent
Crossing Status: Found
UCIP Comments: 07/06/2016 According to LMA Superintendent, Joel McElroy, the posts located on WS are markers indicating line. Line comes from Twitchel Island to Sherman Island. (DWR UCIP - O. Magana)
05/05/2009 Markers Missing. Underground alert service (USA) markings visible on road surface. No markers found to confirm crossing is still in use--need to contact owner to determine status of crossing. (DWR UCIP - O. Magana)
FIELD_STRUCT_DESC: 3-inch electrical transmission cable of unknown material through the levee, 3.5 feet below the crown. Location marker located on the waterside (WS) shoulder--no marker found in 2013. Pole located on the landside (LS). Rock revetment along the on WS slope. (Permit No. 6297, 1969 - Pacific Gas and Electric Company [PG&E]) [Additional Reference(s): DWR Levee Log, 1992. LMA encroachment station (STA) reference based on Map of Evacuation Route, Reclamation District 341 Sherman Island by Wagner Bonsignore Consulting Civil Engineers, A Corporation dated July 2012, STA 148+00]

Underground Service Alert (USA) markings on road surface indicating line is still present.

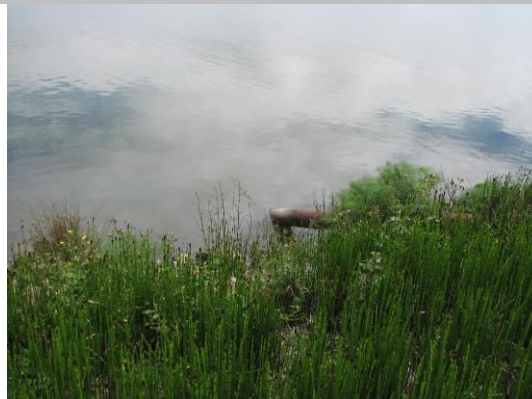
Photo 2 of 3 : UCIP_SP_2020_52254_37658.jpg

Comment Code						
Inspector Comment						
DS_ID:24111 FS_ID:52254 EP_NO: 1477 Repair Type: Non-Urgent Crossing Status: Found UCIP Comments: 07/06/2016 According to LMA Superintendent, Joel McElroy, the LS pipe section was replaced in about 2005 under the Three Mile Slough Project. No work was completed on crown or WS. (DWR UCIP - O. Magana) 05/05/2009 Dense vegetation limits the inspector's visibility to identify signs of pipe failure (leaks) along the slopes. Recommend removing vegetation along pipe alignment to conduct proper inspection of structure and appurtenances. (DWR UCIP - O. Magana) FIELD_STRUCT_DESC: 10-inch steel irrigation siphon pipe through the levee, 1.8 feet below the crown. 10-inch pipe is encased in 12-inch corrugated metal conduit under crown. Pump is located on landside (LS). Air vent and metal distribution box with gate are located on the LS. Rock revetment placed along the waterside (WS) slope. A 30-foot section of pipe under the crown was replaced and encased in corrugated metal pipe (CMP) under unknown permit. (10-inch pipe authorized under Permit No. 1477, 1950 - L. J. Anderson) [Additional Reference(s): DWR Levee Log, 1992. USACE Sacramento O&M Manual Unit No. 101, February 1962, (HLM 0.50). LMA encroachment station (STA) reference based on Map of Evacuation Route, Reclamation District 341 Sherman Island by Wagner Bonsignore Consulting Civil Engineers, A Corporation dated July 2012, STA 149+00] FS Date: 5/5/2009

Pipe visible from WS.

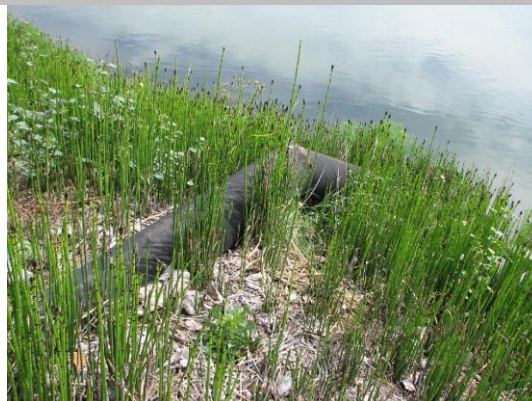
Photo 3 of 3 : UCIP_SP_2020_52254_37655.jpg

View of pipe on WS.

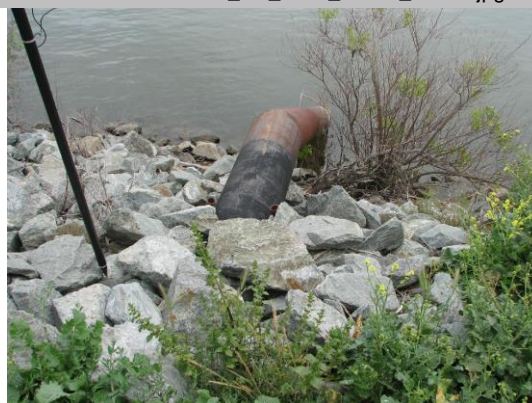
Photo 1 of 3 : UCIP_SP_2020_52255_37664.jpg

Comment Code						
Inspector Comment						
DS_ID:24113 FS_ID:52255 EP_NO: 11095 Repair Type: Non-Urgent Crossing Status: Found UCIP Comments: 07/06/2016 According to LMA Superintendent, Joel McElroy, this pipe is an irrigation siphon pipe and not a drainage pipe. Primer stem and primer is located on the LS near the berry shrubs. (DWR UCIP - O. Magana) 05/05/2009 Dense vegetation limits the inspector's visibility to identify signs of pipe failure (leaks) along the slope. Recommend removing vegetation along pipe alignment to conduct proper inspection of structure and appurtenances. (DWR UCIP - O. Magana) FIELD_STRUCT_DESC: 18-inch steel irrigation siphon pipe sleeved through 24-inch pipe through the levee, 4 feet below the crown. Primer stem and primer located on the landside (LS). Pipe exposed on the waterside (WS) slope. (18-inch pipe authorized under Automatic Board Order (ABO) issued as Permit No. 11095, 1975 - A. M. Cabral). [Additional Reference(s): DWR Levee Log, 1992. LMA encroachment station (STA) reference based on Map of Evacuation Route, Reclamation District 341 Sherman Island by Wagner Bonsignore Consulting Civil Engineers, A Corporation dated July 2012, STA 118+00] FS Date: 5/5/2009

View of pipe located on WS.

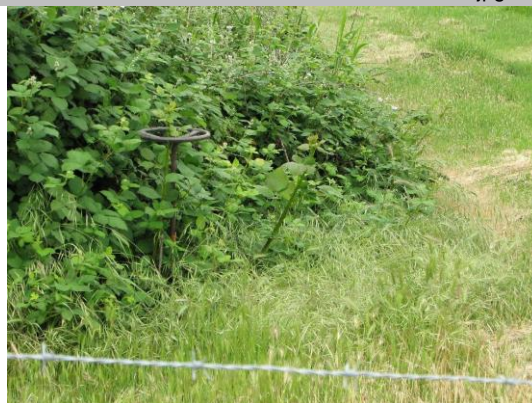
Photo 3 of 3 : UCIP_SP_2020_52255_37662.jpg

Gate located past the fence area near LS toe.

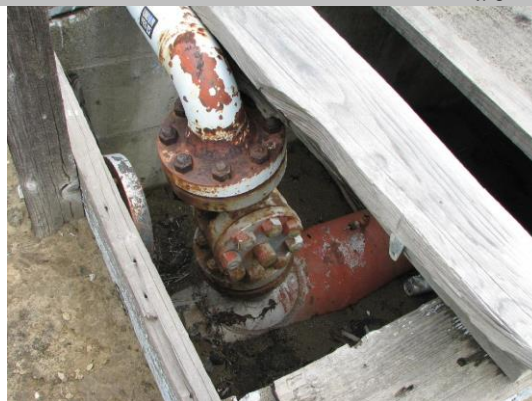
Photo 3 of 3 : UCIP_SP_2020_52256_37674.jpg

View of pipe inside concrete box located on LS.

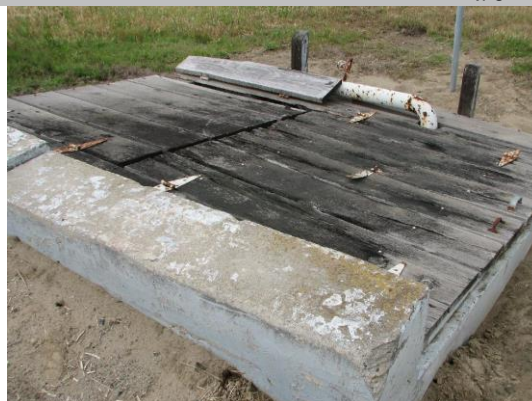
Photo 1 of 3 : UCIP_SP_2020_52257_37680.jpg

Concrete box located on LS.

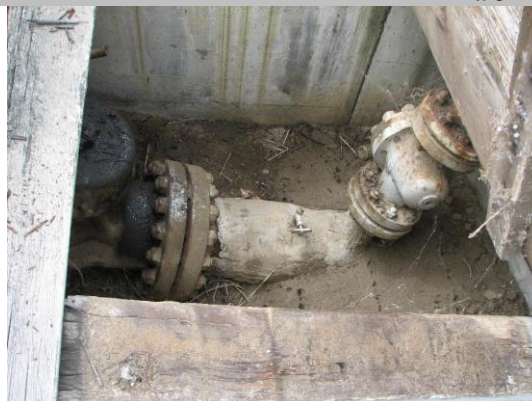
Photo 2 of 3 : UCIP_SP_2020_52257_37677.jpg

Inside view of vault located on the LS.

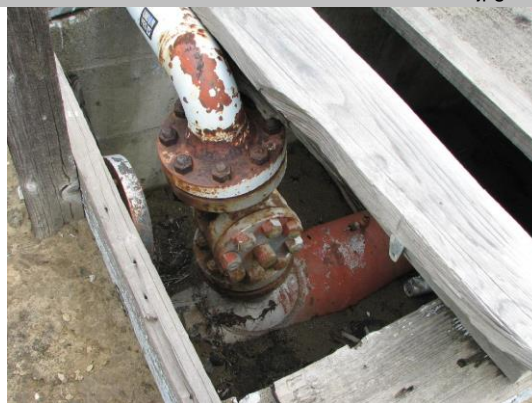
Photo 3 of 3 : UCIP_SP_2020_52257_37679.jpg

View of pipe inside concrete box located on LS.

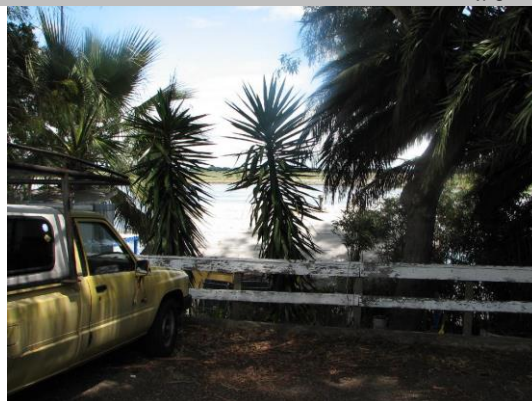
Photo 1 of 3 : UCIP_SP_2020_52258_37706.jpg

DS_ID:24116
FS_ID:52258
EP_NO: 11103
Repair Type: Non-Urgent
Crossing Status: Found
UCIP Comments: 05/05/2009 Unable to determine if crossing is the same as permitted under permit no. 11103. Need to contact owner and determine status of crossing under permit no. 11103. Believe steel conduit is exposed on landward side. (DWR UCIP - O. Magana)
FIELD_STRUCT_DESC: 1.5-inch iron water pipe and 3.5-inch electrical steel conduit through the levee, both 3 feet below the crown. Pressure system and service pole located on the landside (LS) slope. Fishing resort located on the waterside (WS). (1.5-inch pipe authorized under Automatic Board Order (ABO) issued as Permit No. 11103, 1975 - Western Water Ways, Inc.; 3.5-inch not listed in Permit No. 11103)
[Additional Reference(s): DWR Levee Log, 1992. LMA encroachment station (STA) reference based on Map of Evacuation Route, Reclamation District 341 Sherman Island by Wagner Bonsignore Consulting Civil Engineers, A Corporation dated July 2012, STA 71+00]

View of WS.

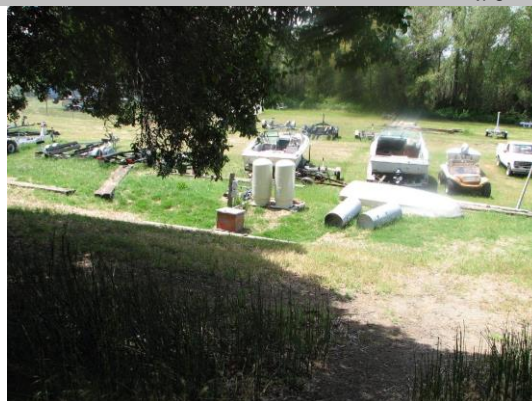
Photo 3 of 3 : UCIP_SP_2020_52258_37703.jpg

View of LS.

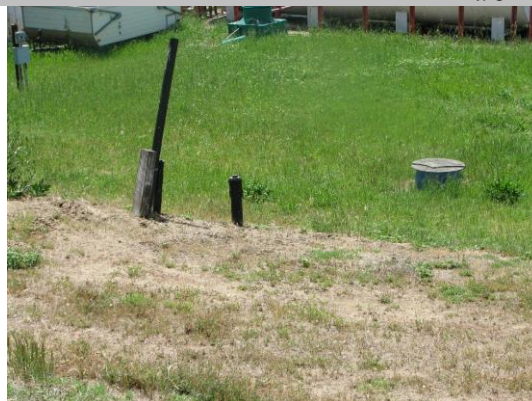
Photo 1 of 3 : UCIP_SP_2020_52259_37712.jpg

Comment Code						
Inspector Comment						
DS_ID:24117 FS_ID:52259 EP_NO: 5427 Repair Type: Non-Urgent Crossing Status: Indicator Found UCIP Comments: 07/06/2016 According to LMA Superintendent, Joel McElroy, the features on the LS include sump pump inside well and drain leach field. The septic line pumps from WS to LS and deposit water in hole. (DWR UCIP - O. Magana) 05/05/2009 Unable to find pipe or sump pump. Indicators found on landward side include potential septic tank and observation well. Need to contact owner of crossing to determine status of crossing. (DWR UCIP - O. Magana) FIELD_STRUCT_DESC: 1 of 2: 4-inch galvanized iron sewage pipe sleeved through 6-inch steel pipe through the levee, 3.7 feet below the crown. Sump pump located on the waterside (WS) slope. Septic tank and observation well are located on the landside (LS). (4-inch pipe authorized under Permit No. 5427, 1966 - Patrick's Resort) [Additional Reference(s): DWR Levee Log, 1992. LMA encroachment station (STA) reference based on Map of Evacuation Route, Reclamation District 341 Sherman Island by Wagner Bonsignore Consulting Civil Engineers, A Corporation dated July 2012, STA 69+00] FS Date: 5/5/2009

View of potential observation well on LS.

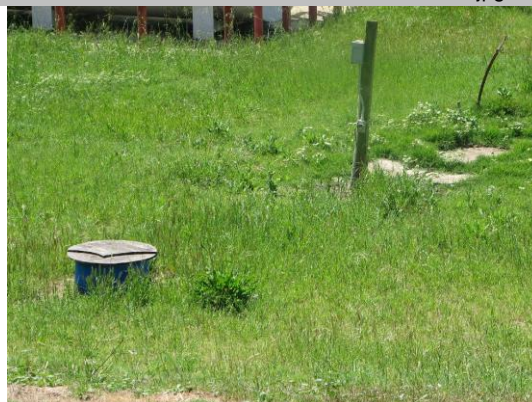
Photo 2 of 3 : UCIP_SP_2020_52259_37711.jpg

LS view: sump pump inside drains to leach field.

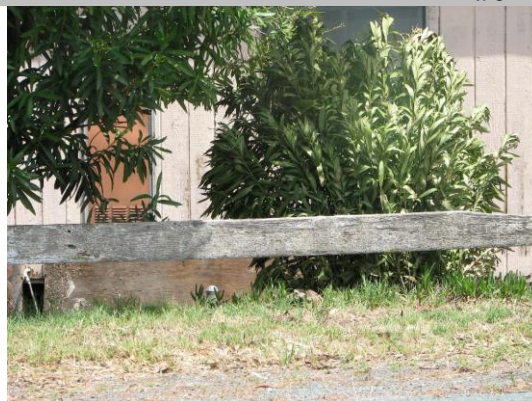
Photo 3 of 3 : UCIP_SP_2020_52259_37710.jpg

View of WS.

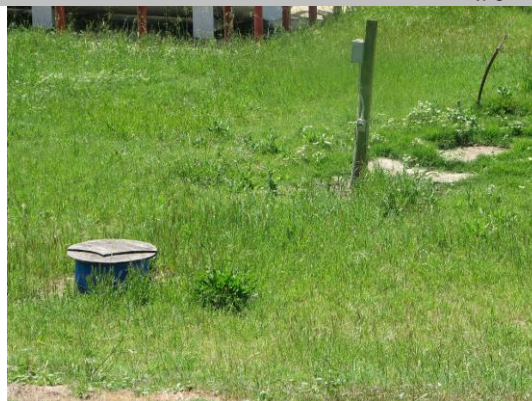
Photo 2 of 2 : UCIP_SP_2020_52260_37716.jpg

DS_ID:24237
 FS_ID:52260
 EP_NO: 5427
 Repair Type: Non-Urgent
 Crossing Status: Indicator Found
 UCIP Comments: 05/05/2009 Signs of electrical connection boxes. Unable to determine if these boxes are associated to crossing. Need to contact owner to determine status of crossing. (DWR UCIP - O. Magana)
 FIELD_STRUCT_DESC: 2 of 2: Five 1 to 1.5-inch pipes through the levee, 3.7 feet below the crown. Pump on waterward slope. Septic tank and observation well on the landward side. (conduit containing 1- to 1.5-inch pipes (per inspector's notes) authorized under Permit No. 5427, 1966 - Patrick's Resort) [Additional Reference(s): DWR Levee Log, 1992. LMA encroachment station (STA) reference based on Map of Evacuation Route, Reclamation District 341 Sherman Island by Wagner Bonsignore Consulting Civil Engineers, A Corporation dated July 2012, STA 68+00]
 FS Date: 5/5/2009

Electrical connection visible next to sump pump--right corner.

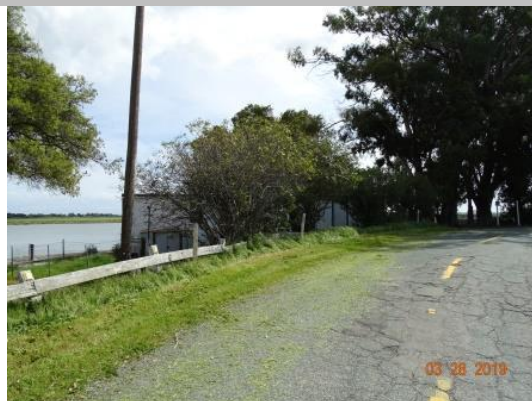
Photo 1 of 1 : SP_2020_RD0341_167_34_20200304_00008.jpg

LM Start	2.00	Rating **	M	Issue No.	34
LM End	2.00	Issue Type +	En	Location *	WS
Category	Earthen Levee			GPS Latitude/Longitude	
				Start	End
Item	Vegetation			38.114129 °	38.114129 °
				-121.684547 °	-121.684547 °
DWR ID	DWR_RD0341_01_s_2019_34				
Comment Code					
V6 : Landscaping					
Inspector Comment

View looking downstream at landscape on the waterside shoulder (Spring 2019).

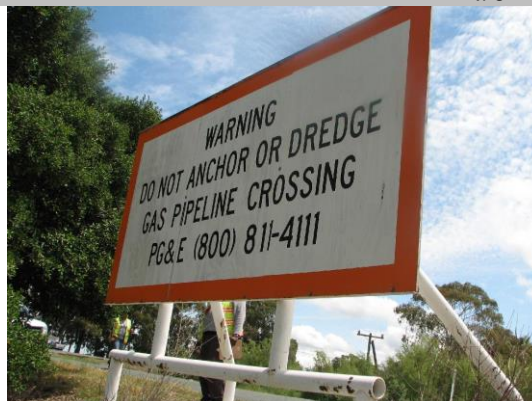
Photo 1 of 2 : UCIP_SP_2020_52261_37719.jpg

DS_ID:24119
FS_ID:52261
EP_NO: 960
Repair Type: Non-Urgent
Crossing Status: Indicator Found
UCIP Comments: 05/05/2009 Need to contact owner to determine last inspection and status of crossing. (DWR UCIP - O. Magana)
FIELD_STRUCT_DESC: 1 of 2: 10-inch steel gas line through the levee, 2 feet below the levee crown. Cutoff wall around pipes located at the center of the levee. Valve pit located on the landside (LS) shoulder, with 2-inch drain pipe along LS slope. Location marker located on the waterside (WS) slope. Contact information for PG&E is 800-811-4111. (two 10-inch line authorized under Permit No. 960, 1944 - Pacific Gas and Electric Company [PG&E]; 10-inch pipes removed through levee-abandoned outside levee and replaced with unknown size pipes, and video inspection on gas line (G/L 169, G/L 302, G/L 131 (p. 24 of 30), and G/L 141 authorized under Permit No. 15319, 1990 - PG&E; line referenced by PG&E as G/L 131) [Additional Reference(s): DWR Levee Log, 1992. USACE Sacramento O&M Manual Unit No. 101, February 1962 (HLM 2.04). LMA encroachment station (STA) reference based on Map of Evacuation Route, Reclamation District 341 Sherman Island by Wagner Bonsignore Consulting Civil Engineers, A Corporation dated July 2012, STA 67+00]

Pipeline marker located on WS shoulder.

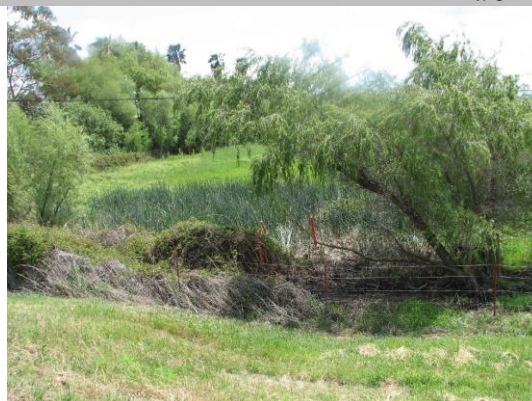
Photo 2 of 2 : UCIP_SP_2020_52261_37718.jpg

LS markers visible near levee toe.

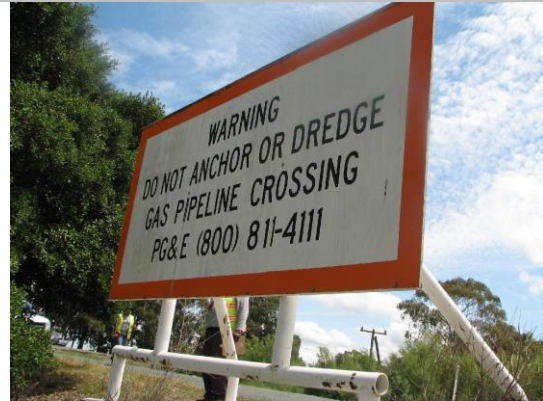
Photo 1 of 2 : UCIP_SP_2020_52263_71847.jpg

Comment Code					
Inspector Comment					
DS_ID:24756 FS_ID:52263 EP_NO: 17251 Repair Type: Non-Urgent Crossing Status: Indicator Found UCIP Comments: 03/04/2014 Need to contact owner to determine status of crossing. Need date of last inspection and confirmation that crossing is still in operable condition. (DWR UCIP - O. Magana) FIELD_STRUCT_DESC: 24-inch steel natural gas line through the levee, 125-feet below the levee crown (24-inch pipe authorized under Permit No. 17251 and 17251-Rev, 2002 - Lodi Gas Storage, LLC). [Additional Reference(s): LMA encroachment station (STA) reference based on Map of Evacuation Route, Reclamation District 341 Sherman Island by Wagner Bonsignore Consulting Civil Engineers, A Corporation dated July 2012, STA 64+00] FS Date: 3/4/2014

View of sign located on WS.

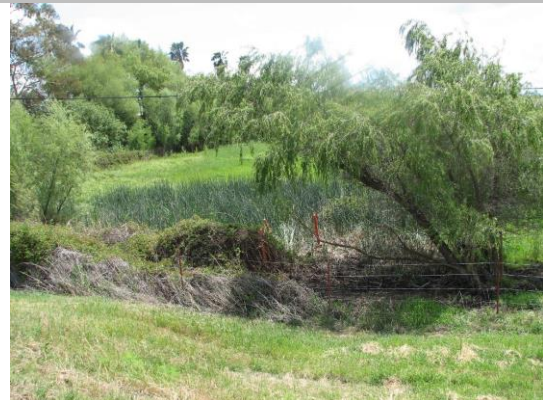
Photo 2 of 2 : UCIP_SP_2020_52263_71846.jpg

Markers visible on LS toe.

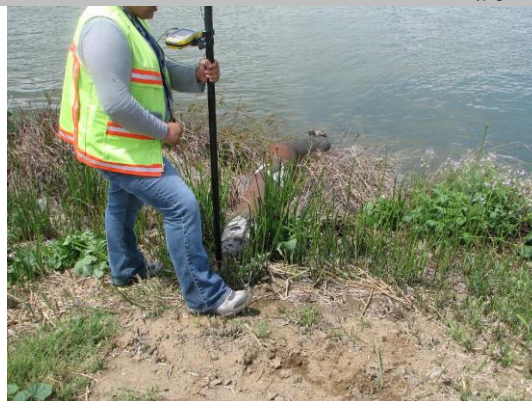
Photo 1 of 3 : UCIP_SP_2020_52264_37734.jpg

DS_ID:24120
FS_ID:52264
EP_NO: 11102
Repair Type: Non-Urgent
Crossing Status: Found
UCIP Comments: 07/06/2016 According to LMA Superintendent, Joel McElroy, the LS pipe was repaired/repared under the Three Mile Slough Project in 2005, Setback Project, Project covers Station 10+00 to 175+00. (DWR UCIP - O. Magana)
05/05/2009 Dense vegetation limits the inspector's visibility to identify signs of pipe failure (leaks) along the slope. Recommend removing vegetation along pipe alignment to conduct proper inspection of structure and appurtenances. (DWR UCIP - O. Magana)
FIELD_STRUCT_DESC: 10-inch steel irrigation pipe sleeved through a 12-inch pipe through the levee, 4.6 feet below the levee crown. Annular gap grouted between pipes. Irrigation canal with distribution box located on the landside (LS) toe. Rock revetment is located on the waterside (WS) slope. (10-inch pipe authorized under Automatic Board Order (ABO) issued as Permit No. 11102, 1975 - C. and E. Silva) [Additional Reference(s): DWR Levee Log, 1992. USACE Sacramento O&M Manual Unit No. 101, February 1962 (HLM 2.33). LMA encroachment station (STA) reference based on Map of Evacuation Route, Reclamation District 341 Sherman Island by Wagner Bonsignore Consulting Civil Engineers, A Corporation dated July 2012, STA 51+00]

View of pipe on WS.

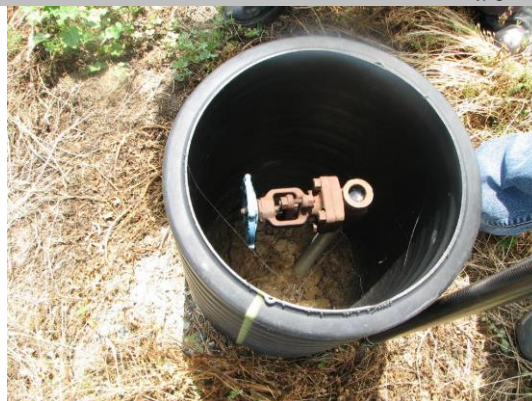
Photo 3 of 3 : UCIP_SP_2020_52264_37732.jpg

Primer stem located on LS slope.

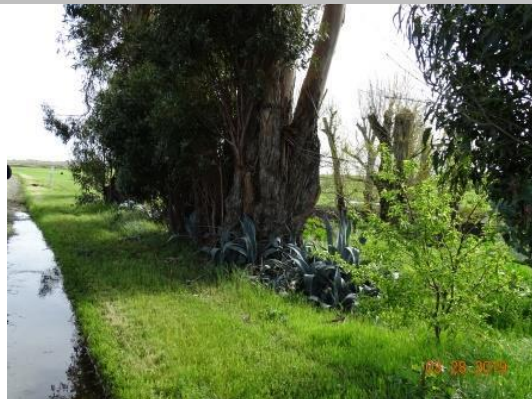
Photo 1 of 1 : SP_2020_RD0341_167_27_20200304_00004.jpg

LM Start	2.90	Rating **	M	Issue No.	27
LM End	2.90	Issue Type +	En	Location *	LS
Category	Earthen Levee			GPS Latitude/Longitude	
				Start	End
Item	Vegetation			38.104602 °	38.104602 °
				-121.694722 °	-121.694722 °
DWR ID	DWR_RD0341_01_s_2019_27				
Comment Code					
V6 : Landscaping					
Inspector Comment					
Cactus is blocking access down the landside slope.

View looking downstream at cactus on the landside slope (Spring 2019).

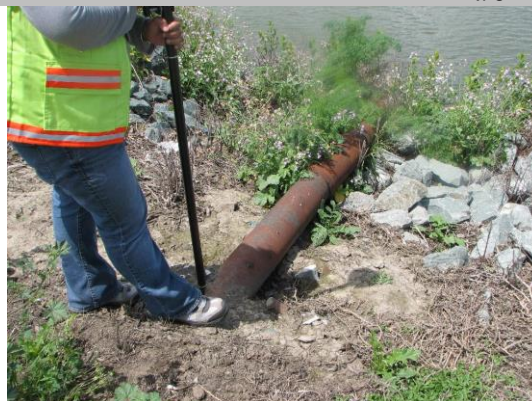
Photo 1 of 3 : UCIP_SP_2020_52265_37750.jpg

Comment Code					
Inspector Comment					
DS_ID:24121 FS_ID:52265 EP_NO: N/A Repair Type: Non-Urgent Crossing Status: Found UCIP Comments: 07/06/2016 According to LMA Superintendent, Joel McElroy, the LS pipe was repaired/repaired under the Three Mile Slough Project in 2005, Setback Project, Project covers Station 10+00 to 175+00. (DWR UCIP - O. Magana) 05/05/2009 Pipe size does not match -- found 10 inch instead of 8 inch. Pipe (1 of 2) was supposed to be removed and replaced with 12-inch steel irrigation pipes under Permit No. 5629 (1966). Historical Levee Logs from 1992 do not reflect that the replacement was completed, verify diameter of pipes and status with applicant. Dense vegetation limits the inspector's visibility to identify signs of pipe failure (leaks) along the slope. Recommend removing vegetation along pipe alignment to conduct proper inspection of structure and appurtenances. (DWR UCIP - O. Magana) FIELD_STRUCT_DESC: 1 of 2: 10-inch (not 8-inch as originally noted in records) steel irrigation pipe through the levee, 1.4 feet below the crown. Siphon breaker is located on the landside (LS). Irrigation ditch with distribution box is located on LS toe. Pipe exposed on both slopes. Rock revetment present along on waterside (WS) slope. [Additional Reference(s): DWR Levee Log, 1992. USACE Sacramento O&M Manual Unit No. 101, February 1962 (HLM 2.93), two 8-inch pipes. LMA encroachment station (STA) reference based on Map of Evacuation Route, Reclamation District 341 Sherman Island by Wagner Bonsignore Consulting Civil Engineers, A Corporation dated July 2012, STA 20+00] FS Date: 5/5/2009

View of pipe and rip rap located on WS.

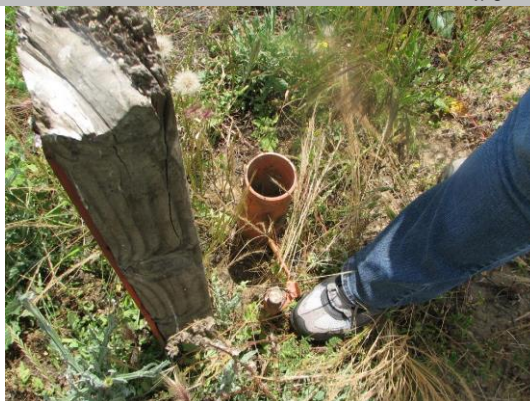
Photo 2 of 3 : UCIP_SP_2020_52265_37747.jpg

Small stand pipe (primer) located on LS--unknown purpose of stand pipe.

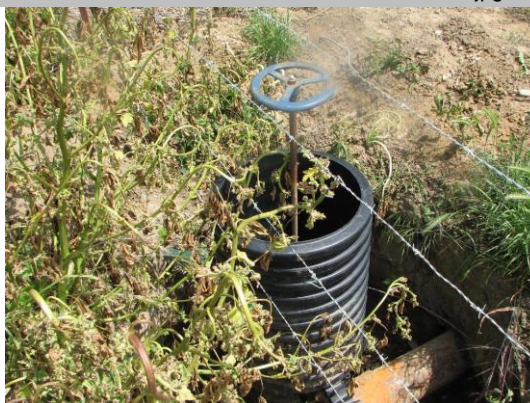
Photo 3 of 3 : UCIP_SP_2020_52265_37749.jpg

New distribution box and valve located on LS.

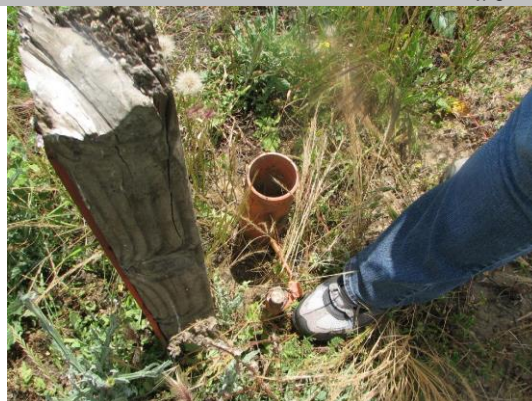
Photo 2 of 3 : UCIP_SP_2020_52266_37755.jpg

Comment Code						
Inspector Comment						
DS_ID:24238 FS_ID:52266 EP_NO: N/A Repair Type: Non-Urgent Crossing Status: Indicator Found UCIP Comments: 07/06/2016 According to LMA Superintendent, Joel McElroy, the LS pipe was repaired/repaired under the Three Mile Slough Project in 2005, Setback Project, Project covers Station 10+00 to 175+00. (DWR UCIP - O. Magana) 05/05/2009 Pipe size does not match--found 10 inch instead of 8 inch. Pipe (2 of 2) was supposed to be removed and replaced with 12-inch steel irrigation pipes under Permit No. 5629 (1966). Historical Levee Logs from 1992 do not reflect that the replacement was completed, verify diameter of pipes and status with applicant. Dense vegetation limits the inspector's visibility to identify signs of pipe failure (leaks) along the slope. Recommend removing vegetation along pipe alignment to conduct proper inspection of structure and appurtenances. (DWR UCIP - O. Magana) FIELD_STRUCT_DESC: 2 of 2: 10-inch (not 8-inch as originally mentioned in desk study) steel irrigation pipe through the levee, 1.6 feet below the crown. Siphon breaker located on the landside (LS). Irrigation ditch with distribution box located on the LS toe. Pipe exposed on both slopes. Rock revetment placed on waterside (WS) slope. [Additional Reference(s): DWR Levee Log, 1992. USACE Sacramento O&M Manual Unit No. 101, February 1962 (HLM 2.93), two 8-inch pipes. LMA encroachment station (STA) reference based on Map of Evacuation Route, Reclamation District 341 Sherman Island by Wagner Bonsignore Consulting Civil Engineers, A Corporation dated July 2012, STA 20+00] FS Date: 5/5/2009

Small stand pipe (primer) located on LS--unknown purpose of stand pipe.

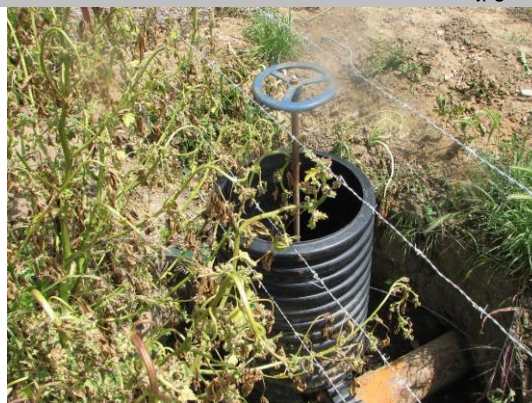
Photo 3 of 3 : UCIP_SP_2020_52266_37757.jpg

New distribution box and valve located on LS.

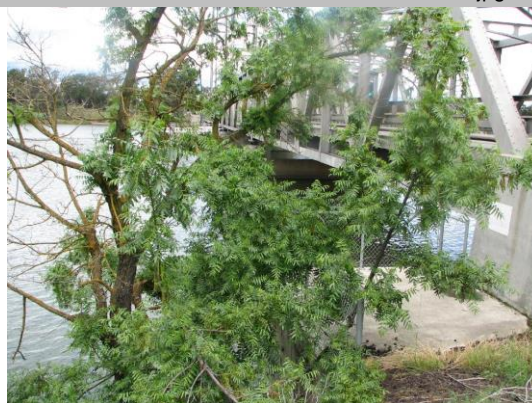
Photo 1 of 3 : UCIP_SP_2020_52267_37780.jpg

Comment Code					
Inspector Comment					
DS_ID:24245 FS_ID:52267 EP_NO: N/A Repair Type: Non-Urgent Crossing Status: Found UCIP Comments: 07/06/2016 According to LMA Superintendent, Joel McElroy, the pipe does not go through the levee. This pipe belongs to Caltrans. Need to contact Caltrans to obtain As-builts for this crossing. (DWR UCIP - O. Magana) 05/05/2009 New crossing found in field--need to find owner and determine permit authorizing work. (DWR UCIP - O. Magana) FIELD_STRUCT_DESC: *NOT THROUGH LEVEE* 10-inch corrugated metal pipe extruding from the waterside (WS) slope. [Additional Reference(s): LMA encroachment station (STA) reference based on Map of Evacuation Route, Reclamation District 341 Sherman Island by Wagner Bonsignore Consulting Civil Engineers, A Corporation dated July 2012, STA 1025+00] FS Date: 5/5/2009

View of WS.

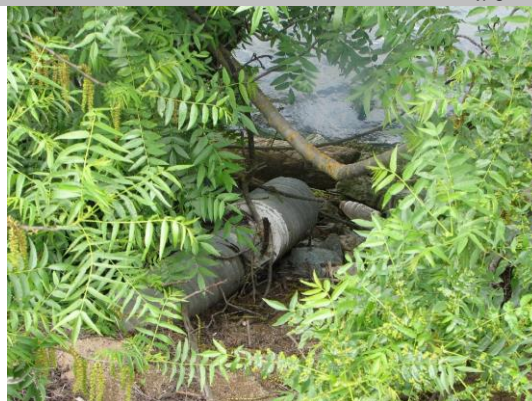
Photo 2 of 3 : UCIP_SP_2020_52267_37783.jpg

Pipe visible on the WS.

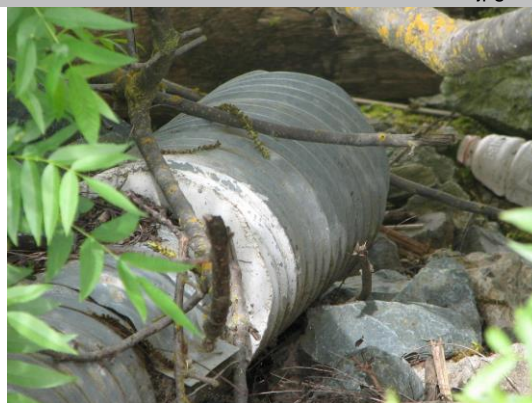
Photo 3 of 3 : UCIP_SP_2020_52267_37781.jpg

View of corrugated metal pipe on WS.

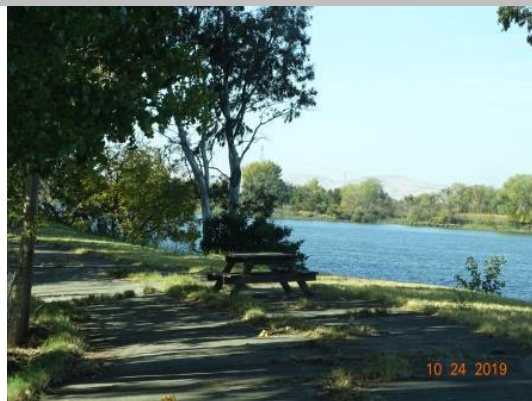
Photo 1 of 1 : SP_2020_RD0341_168_36_20200304_00004.jpg

LM Start	3.40	Rating **	M	Issue No.	36
LM End	3.40	Issue Type +	En	Location *	CR
Category	Earthen Levee			GPS Latitude/Longitude	
				Start	End
Item	Encroachments			38.105285 °	38.105285 °
				-121.703383 °	-121.703383 °
DWR ID	DWR_RD0341_02_f_2019_36				
Comment Code					
EQ : Equipment					
Inspector Comment

View of picnic table in the middle of the crown (Fall 2019).

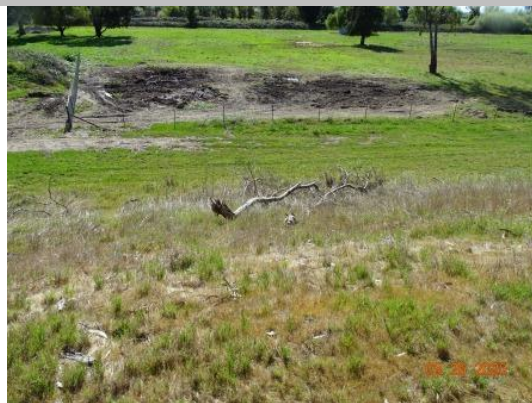
Photo 1 of 1 : SP_2020_RD0341_168_39_20200326_00087.jpg

View of down tree limb on landside slope (Spring 2020).

LM Start	3.55	Rating **	M	Issue No.	39
LM End	3.55	Issue Type +	Ma	Location *	LS
Category	Earthen Levee			GPS Latitude/Longitude	
				Start	End
Item	Encroachments			38.103562 °	38.103562 °
				-121.705045 °	-121.705045 °
DWR ID	DWR_RD0341_02_s_2020_39				
Comment Code					
TR : Tree or limb					
Inspector Comment					
Remove tree limb from landside slope

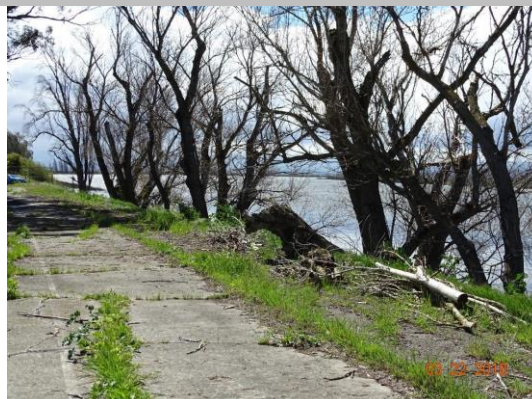
Photo 1 of 1 : SP_2020_RD0341_168_46_20200304_00011.jpg

Tree trunk and limbs should be removed from waterside shoulder.

LM Start	3.88	Rating **	M	Issue No.	46
LM End	3.93	Issue Type +	Ma	Location *	WS
Category	Earthen Levee			GPS Latitude/Longitude	
				Start	End
Item	Encroachments			38.099054 °	38.098327 °
				-121.706368 °	-121.706272 °
DWR ID	DWR_RD0341_02_s_2020_46				
Comment Code					
TR : Tree or limb					
Inspector Comment					
Remove tree and limbs from waterside shoulder.

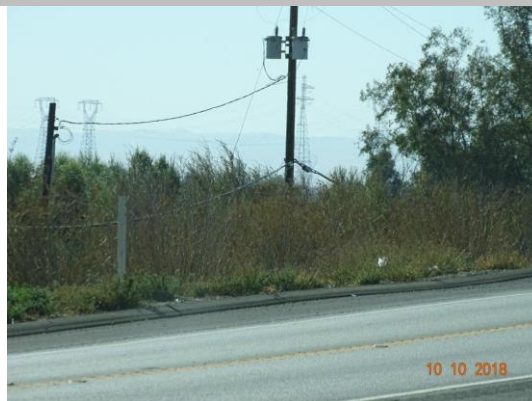
Photo 1 of 2 : SP_2020_RD0341_168_43_20200304_00008.jpg

LM Start	3.97	Rating **	M	Issue No.	43
LM End	6.03	Issue Type +	Ma	Location *	LS
Category	Earthen Levee			GPS Latitude/Longitude	
				Start	End
Item	Vegetation			38.097782 °	38.080143 °
				-121.706262 °	-121.728330 °
DWR ID	DWR_RD0341_02_f _ 2017_43				
Comment Code					
V2 : Remove the wild growth other than native grasses from the levee slopes.					
Inspector Comment

View of vegetation on the land side slope where the levee is on Highway 160 (October 2018).

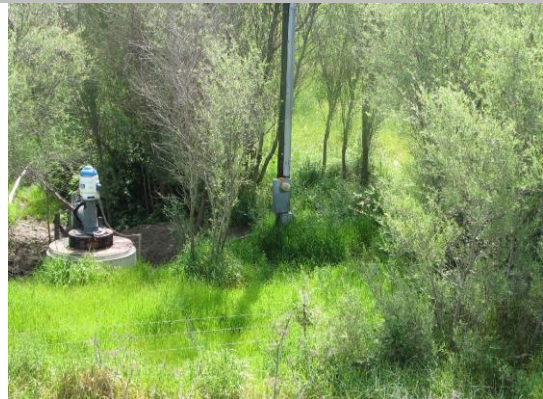
Photo 3 of 3 : UCIP_SP_2020_22203_37835.jpg

View of well and pump located on landward side.

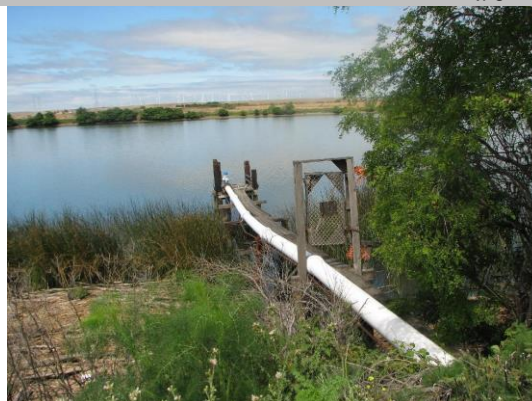
Photo 1 of 1 : UCIP_SP_2020_22223_37840.jpg

Comment Code						
Inspector Comment						
DS_ID:24122 FS_ID:22223 EP_NO: 11106 Repair Type: Non-Urgent Crossing Status: Found UCIP Comments: 07/06/2016 According to LMA Superintendent, Joel McElroy, DWR acquired land in 1995-2000 maybe earlier. Need to determine DWR Office is responsible for RD0341. Need to contact owner determine fate of crossing. (DWR UCIP - O. Magana) 05/06/2016 Need to contact owner to determine status of crossing. Dense vegetation limits the inspector's visibility to identify signs of pipe failure (leaks) along the slope. Recommend removing vegetation along pipe alignment to conduct proper inspection of structure and appurtenances. (DWR UCIP - O. Magana) FIELD_STRUCT_DESC: 12-inch pipe through the levee, 4 feet below the crown. Pump on pile structure in stream. (12-inch pipe authorized under Automatic Board Order (ABO) issued as Permit No. 11106, 1975 - A. and M. E. Cabral) [Additional Reference(s): DWR Levee Log, 1992. USACE Sacramento O&M Manual Unit No. 101, February 1962, (HLM 4.29). LMA encroachment station (STA) reference based on Map of Evacuation Route, Reclamation District 341 Sherman Island by Wagner Bonsignore Consulting Civil Engineers, A Corporation dated July 2012, STA 974+00] FS Date: 5/6/2009

View of waterward side--pipe and pump visible.

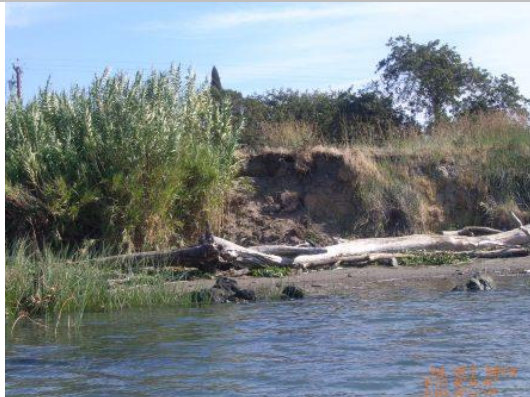
Photo 1 of 1 : SP_2020_RD0341_168_35_20200304_00003.jpg

LM Start	4.47	Rating **	U	Issue No.	35
LM End	4.70	Issue Type +	Ma	Location *	WS
Category	Supplemental			GPS Latitude/Longitude	
				Start	End
Item	2017 USACE Erosion Survey			38.090620 °	38.087425 °
				-121.706684 °	-121.707639 °
DWR ID	DWR_RD0341_02_f _ 2018_35				
Comment Code					
Inspector Comment					
2017 Site ID: SAC 8.0 L					
Status: Critical					
2017 Field Notes: Site extended downstream					
Site History: 1999 - New small slump in eroded bank. 2005 - Reach extended because of vertical bank along the roadway upstream. 2011 - More slumping since last year. 2012 - Site upgraded to critical. Very steep slope which may be effecting the highway on top of the levee. 2015 - New erosion towards the downstream end of site.

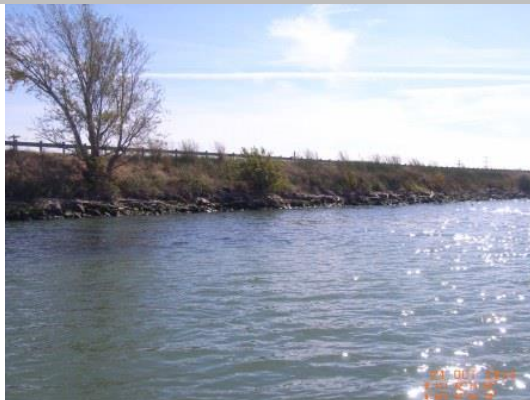
Photo 1 of 1 : SP_2020_RD0341_168_34_20200304_00002.jpg

LM Start	4.76	Rating **	A/W	Issue No.	34
LM End	5.01	Issue Type +	Ma	Location *	WS
Category	Supplemental			GPS Latitude/Longitude	
				Start	End
Item	2017 USACE Erosion Survey			38.086603 °	38.083954 °
				-121.707786 °	-121.710589 °
DWR ID	DWR_RD0341_02_f_2018_34				
Comment Code					
Inspector Comment					
2017 Site ID: SAC 7.9 L					
Status: Critical					
2017 Field Notes: Road base exposed in multiple locations. New tree popout observed.					
Site History: 2011 - Large slump section. 2012 - Site extended downstream, upgraded to critical, severe windwave. Slope is very steep and may be effecting the highway on top of the levee.

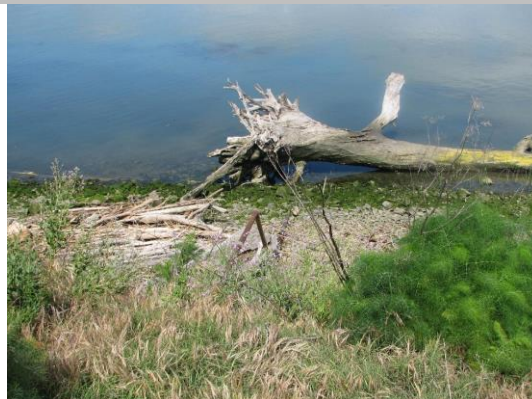
Photo 1 of 2 : UCIP_SP_2020_22186_37787.jpg

DS_ID:24123
FS_ID:22186
EP_NO: 4855
Repair Type: Non-Urgent
Crossing Status: Found
UCIP Comments: Dense vegetation limits the inspector's visibility to identify signs of pipe failure (leaks) along the slope. Recommend removing vegetation along pipe alignment to conduct proper inspection of structure and appurtenances.
FIELD_STRUCT_DESC: 2-inch steel irrigation pipe through the levee, 3.0 feet below the crown. Valve and pump on landside (LS). Rock revetment placed on waterside (WS) slope. (2-inch pipe authorized under Permit No. 4855, 1965 - A. Cabral) [Additional Reference(s): DWR Levee Log, 1992. LMA encroachment station (STA) reference based on Map of Evacuation Route, Reclamation District 341 Sherman Island by Wagner Bonsignore Consulting Civil Engineers, A Corporation dated July 2012, STA 948+00]
FS Date: 5/6/2009

View of crossing on waterward side--dense vegetation on slopes.

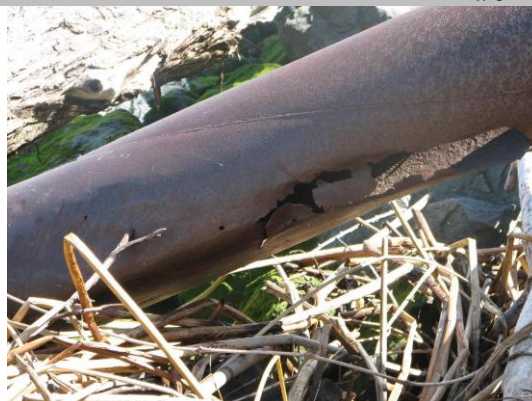
Photo 2 of 3 : UCIP_SP_2020_53343_37841.jpg

DS_ID:24124
FS_ID:53343
EP_NO: 1806
Repair Type: Urgent
Crossing Status: Found
UCIP Comments: 9/5/2018 WS pipe end is severely corroded through and the LS pipe could not be found. Talked to LMA Rep and this pipe is no longer in use. Recommend internal inspection through levee due to pipe condition concern and so crossing remains Urgent (D. Sanoski - DWR UCIP).7/6/2016 Meet with Joel McElroy, District Representative, at site. Difficult to access pipe from WS due to high traffic on levee crown and large debris scattered on WS toe. According to Joel McElroy, crossing is still present. Unable to access crossing from WS toe. Access should be made via boat. Assume crossing has gotten worse from last site visit. Need to find owner and coordinate with CVFPB to remove pipe. Mr. McElroy mentioned that Caltrans will be working on the Pavement Rehabilitation Project on State Route 160 and this crossing might be addressed by them. Project Manager for Pavement Rehabilitation Project is Kidianga Tshiunza, Caltrans District 3, 530-741-4178. (DWR UCIP - omagana)5/6/2009 Crossing has failed. Large holes present on waterward side. Need to contact owner. Crossing needs to be addressed. Dense vegetation limits the inspector's visibility to identify signs of pipe failure (leaks) along the slope. Recommend removing vegetation along pipe alignment to conduct proper inspection of structure and appurtenances. (DWR UCIP - omagana)

Holes present on waterward side.

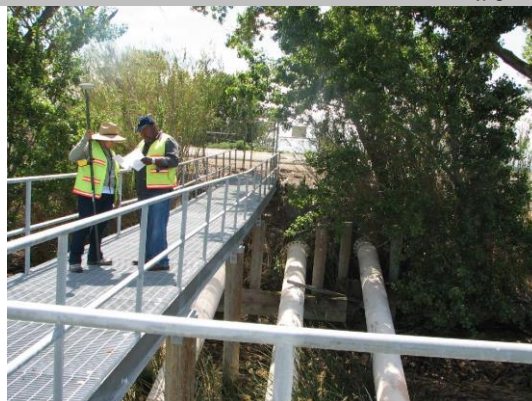
Photo 1 of 3 : UCIP_SP_2020_22253_37885.jpg

DS_ID:24195
FS_ID:22253
EP_NO: 15175
Repair Type: Non-Urgent
Crossing Status: Found
UCIP Comments: Dense vegetation limits the inspector's visibility to identify signs of pipe failure (leaks) along the slope. Recommend removing vegetation along pipe alignment to conduct proper inspection of structure and appurtenances.
FIELD_STRUCT_DESC: [Horseshoe Intake] 1 of 4: 24-inch steel irrigation pipe in 30-inch steel casings through the levee, 6.6 feet below the crown. Annular gap grouted between pipes. Siphon breakers located on the waterside (WS) shoulder, with concrete risers on both ends. Screened inlet manifold (36-inch) with backwash system on pile structure in stream. Surrounded by fence with entry gate. Irrigation pond located on the landside (LS) toe. (three 24-inch pipe authorized under Permit No. 15175, 1993 -Reclamation District 341 [RD0341]; replacement of 210 feet of existing 24-inch pipes, join two pipes at an inlet with a 36-inch screened manifold intake, add bypass valves on both lines, install an access platform, and pressurized backwash system to clean fish screens authorized under Permit No. 16737, 2000 - Department of Water Resources [DWR]) [Additional Reference(s): LMA encroachment station (STA) reference based on Map of Evacuation Route, Reclamation District 341 Sherman Island by Wagner Bonsignore Consulting Civil Engineers, A Corporation dated July 2012, STA 934+00]

Pipes, walkway, fence, and support piles located on waterward side.

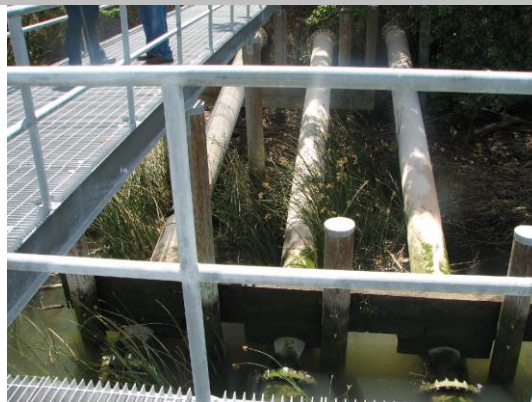
Photo 2 of 3 : UCIP_SP_2020_22253_37882.jpg

View of waterward side - 3-20 inch pipes.

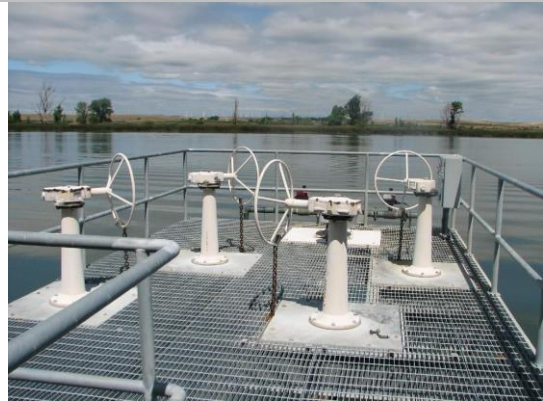
Photo 3 of 3 : UCIP_SP_2020_22253_37881.jpg

Gates located on waterward side.

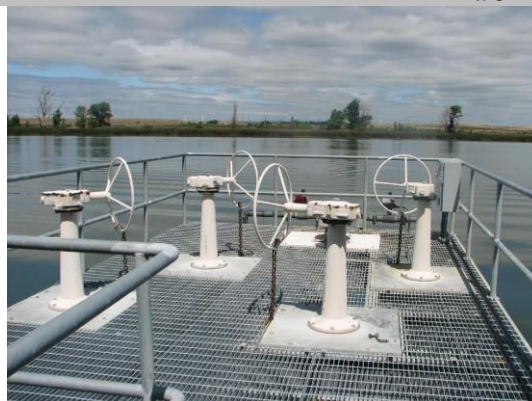
Photo 3 of 3 : UCIP_SP_2020_22254_37897.jpg

Gates located on waterward side.

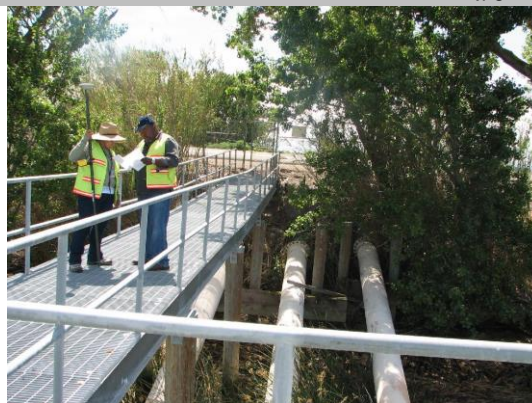
Photo 1 of 3 : UCIP_SP_2020_22255_37911.jpg

DS_ID:24240
FS_ID:22255
EP_NO: 15175
Repair Type: Non-Urgent
Crossing Status: Found
UCIP Comments: Dense vegetation limits the inspector's visibility to identify signs of pipe failure (leaks) along the slope. Recommend removing vegetation along pipe alignment to conduct proper inspection of structure and appurtenances.
FIELD_STRUCT_DESC: [Horseshoe Intake] 3 of 4: 24-inch steel irrigation pipe in 30-inch steel casings through the levee, 6.6 feet below the crown. Annular gap grouted. Siphon breakers at waterward shoulder, with concrete risers on both ends. Screened inlet manifold (36-inch) with backwash system on pile structure in stream. Surrounded by fence with entry gate. Irrigation pond at landward toe. (three 24-inch pipe authorized under Permit No. 15175, 1993 -Reclamation District 341 [RD0341]; replacement of 210 feet of existing 24-inch pipes, join two pipes at an inlet with a 36-inch screened manifold intake, add bypass valves on both lines, install an access platform, and pressurized backwash system to clean fish screens authorized under Permit No. 16737, 2000 - Department of Water Resources [DWR]) [Additional Reference(s): LMA encroachment station (STA) reference based on Map of Evacuation Route, Reclamation District 341 Sherman Island by Wagner Bonsignore Consulting Civil Engineers, A Corporation dated July 2012, STA 934+00]

Pipes, walkway, fence, and support piles located on waterward side.

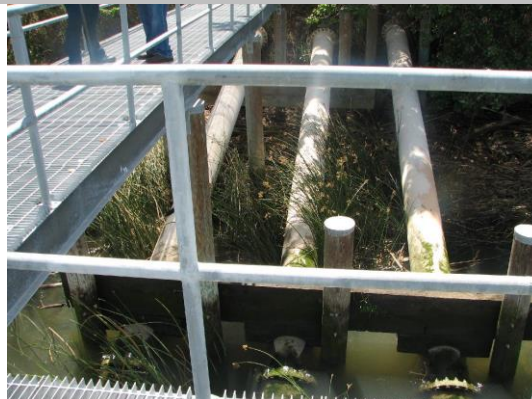
Photo 2 of 3 : UCIP_SP_2020_22255_37909.jpg

View of waterward side - 3-20 inch pipes.

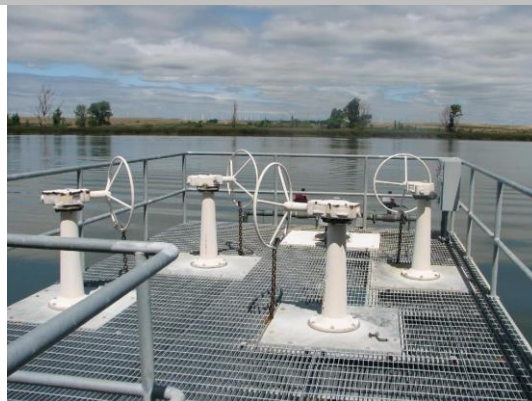
Photo 3 of 3 : UCIP_SP_2020_22255_37908.jpg

Gates located on waterward side.

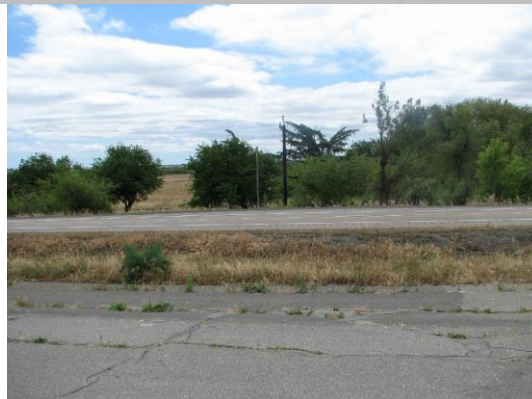
Photo 1 of 3 : UCIP_SP_2020_22256_37915.jpg

DS_ID:24127
FS_ID:22256
EP_NO: 11116
Repair Type: Non-Urgent
Crossing Status: Found
UCIP Comments: Need to coordinate with owner to determine status of crossing. If crossing is no longer in use owner will need to contact the CVFPB to comply with Title 23. Dense vegetation limits the inspector's visibility to identify signs of pipe failure (leaks) along the slope. Recommend removing vegetation along pipe alignment to conduct proper inspection of structure and appurtenances.
FIELD_STRUCT_DESC: 16-inch steel irrigation pipe sleeved through 18-inch pipe through the levee, 2.5 feet below the crown. Annular gap grouted. Air vent on waterside (WS). (16-inch sleeved through 18-inch pipe authorized under Automatic Board Order (ABO) issued as Permit No. 11116, 1975 - C. E. & J. E. Upham; widen and realign State HWY 160 and extend three irrigation pipes authorized under Permit No. 15372, 1993 - Department of Transportation [Caltrans]) [Additional Reference(s): DWR Levee Log, 1992. USACE Sacramento O&M Manual Unit No. 101, February 1962, (HLM 5.40). LMA encroachment station (STA) reference based on Map of Evacuation Route, Reclamation District 341 Sherman Island by Wagner Bonsignore Consulting Civil Engineers, A Corporation dated July 2012, STA 917+00]

Overview of levee crown at crossing.

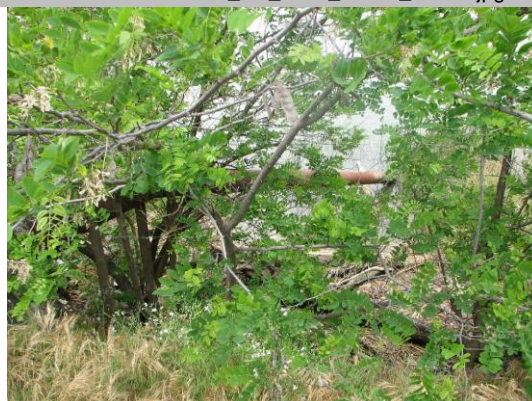
Photo 2 of 3 : UCIP_SP_2020_22256_37914.jpg

View of pipe through brush on waterward side.

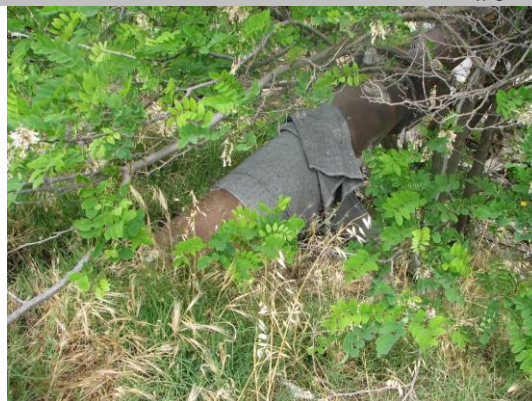
Photo 3 of 3 : UCIP_SP_2020_22256_37917.jpg

Pipe on waterward side at daylight.

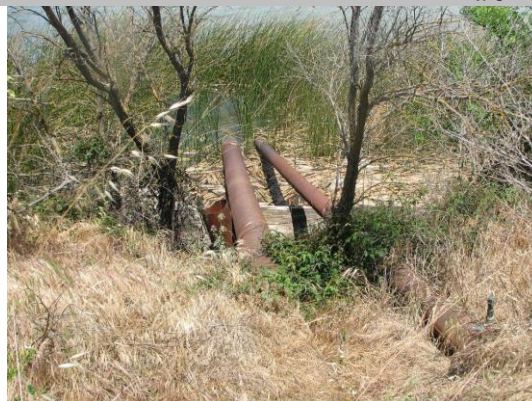
Photo 1 of 3 : UCIP_SP_2020_22258_37932.jpg

8-inch pipe and 14-inch pipe on waterward side.

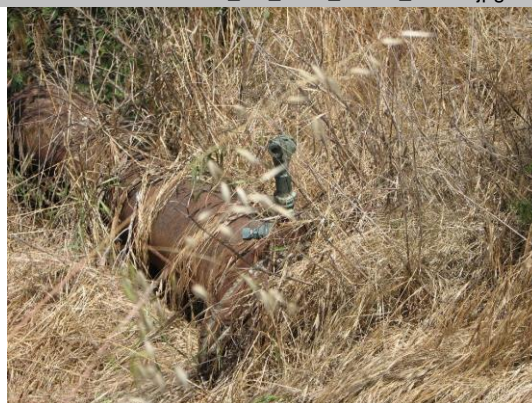
Photo 2 of 3 : UCIP_SP_2020_22258_37930.jpg

Air vent located on waterward side.

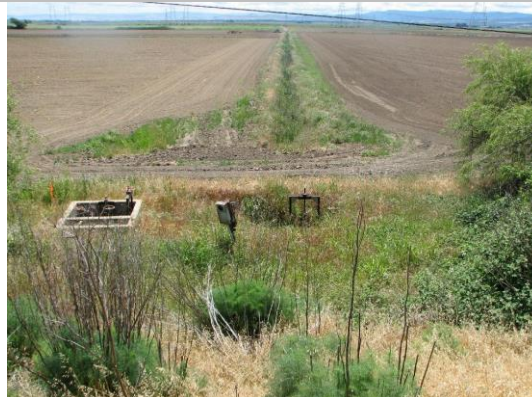
Photo 3 of 3 : UCIP_SP_2020_22258_37931.jpg

LM Start	5.87	Rating **	M	Issue No.	85 (cont)
LM End	5.87	Issue Type +	En	Location *	
Category	Supplemental		GPS Latitude/Longitude		
			Start	End	
Item	DWR UCIP Field Study		38.080381 °	38.080381 °	
			-121.725534 °	-121.725534 °	
DWR ID	24074

View of landward side.

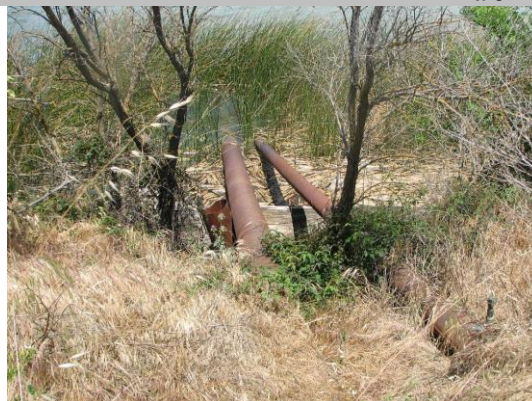
Photo 1 of 3 : UCIP_SP_2020_22259_37935.jpg

DS_ID:24075
FS_ID:22259
EP_NO: 1806
Repair Type: Non-Urgent
Crossing Status: Found
UCIP Comments: Dense vegetation limits the inspector's visibility to identify signs of pipe failure (leaks) along the slope. Recommend removing vegetation along pipe alignment to conduct proper inspection of structure and appurtenances.
FIELD_STRUCT_DESC: 2 of 2: 14-inch steel irrigation pipe through the levee, 3 feet below the crown. Concrete distribution box with gate valve located on the landside (LS) toe. Air vent located on the waterside (WS). (14-inch pipe authorized under Permit No. 1806, 1959 - C. E. Upham, Jr.; distribution box installed and pipe along LS slope removed and replaced with longer 16-inch steel pipe authorized under Permit No. 15372, 1993 - Department of Transportation [Caltrans]) [Additional Reference(s): DWR Levee Log, 1992. USACE Sacramento O&M Manual Unit No. 101, February 1962, (HLM 5.81). LMA encroachment station (STA) reference based on Map of Evacuation Route, Reclamation District 341 Sherman Island by Wagner Bonsignore Consulting Civil Engineers, A Corporation dated July 2012, STA 891+00]

View of pipes on waterward side.

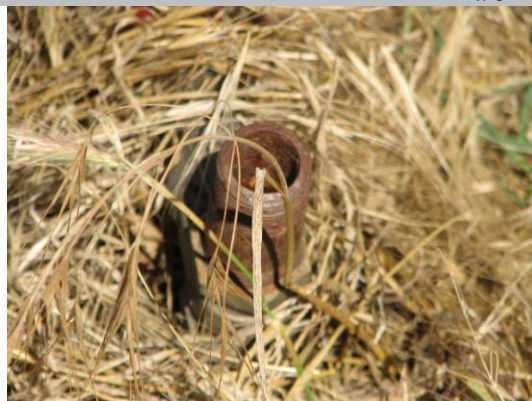
Photo 2 of 3 : UCIP_SP_2020_22259_37936.jpg

Primer stem located on waterward side.
